FHWA/IN/JTRP-99/4

Final Report

**EMBANKMENT WIDENING DESIGN GUIDELINES
AND CONSTRUCTION PROCEDURES**

September 1999

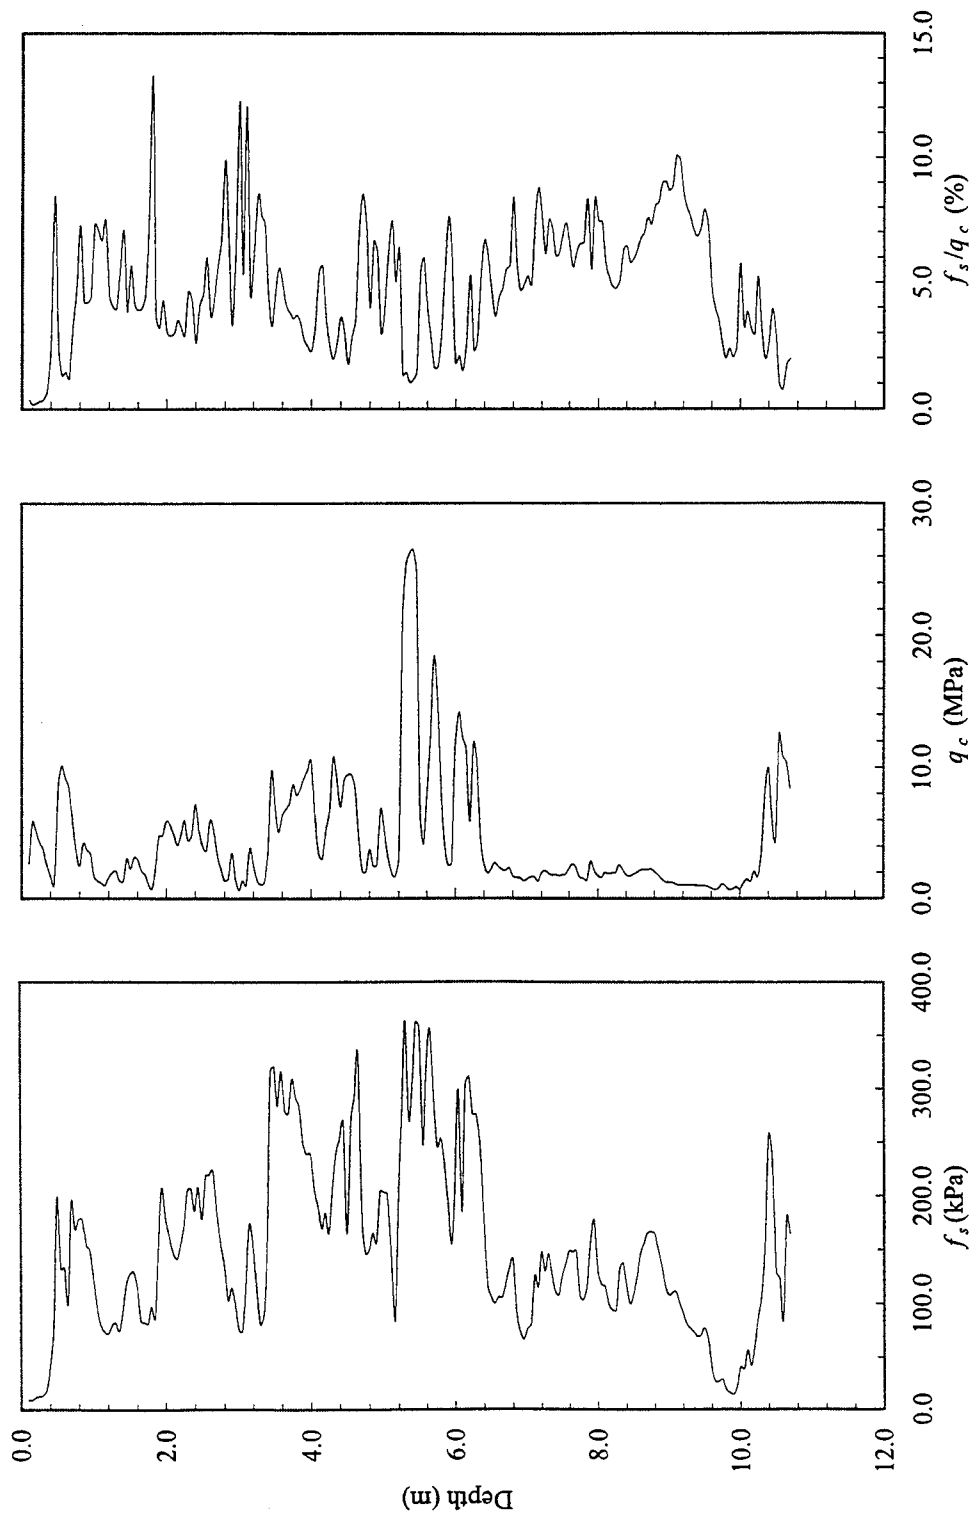
Figure 4.5. Cone penetrometer test data, CPT-710, Sta. 18+874, O.S. 23.48m It., I-69, Madison County, Greenfield District.

Two cone penetration tests (CPT) were performed at this project site by Purdue University. CPT data are presented in Figure 4.5 and Figure 4.6. The tests were performed adjacent to the shoulder of the highway, offset approximately 6 feet from the edge of pavement. CPTs were performed to evaluate the consistency of the embankment. CPT provides a continuous profile of sub-surface stratigraphy; therefore, it is a superb tool for identifying soft zones or other discontinuities in natural and man-made deposits. No apparent weak zones or discontinuities were identified at the locations of the CPTs.

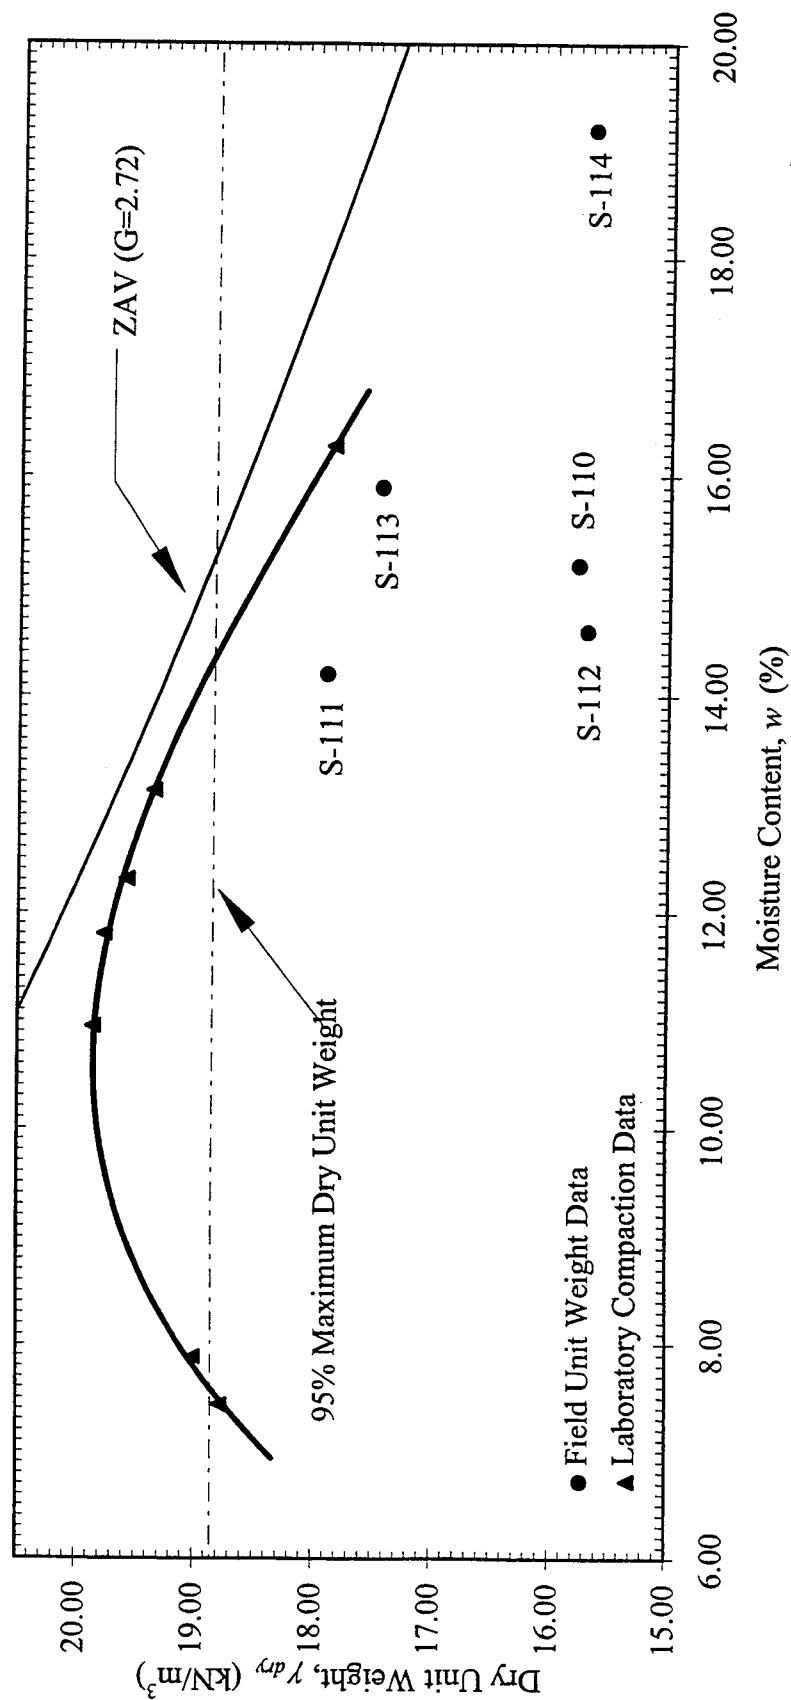
Figure 4.7. Standard Proctor test data and sand-cone data, I-69, Madison County, Greenfield District.

As indicated in Table 4.4, the maximum dry density determined from standard Proctor tests ranged from 1,925 to 2,024 kg/m^3 , and the optimum moisture content ranged from 10.5 to 13.3 percent. Sand-cone tests indicate that relative compaction of the fill used to widen the embankment ranged from approximately 79 to 90 percent. In addition, the moisture contents determined for the field density tests indicate that the soils ranged

from 3.7 to 8.7 percent wet of optimum. These data and the moisture density relationship are presented in Figure 4.7.

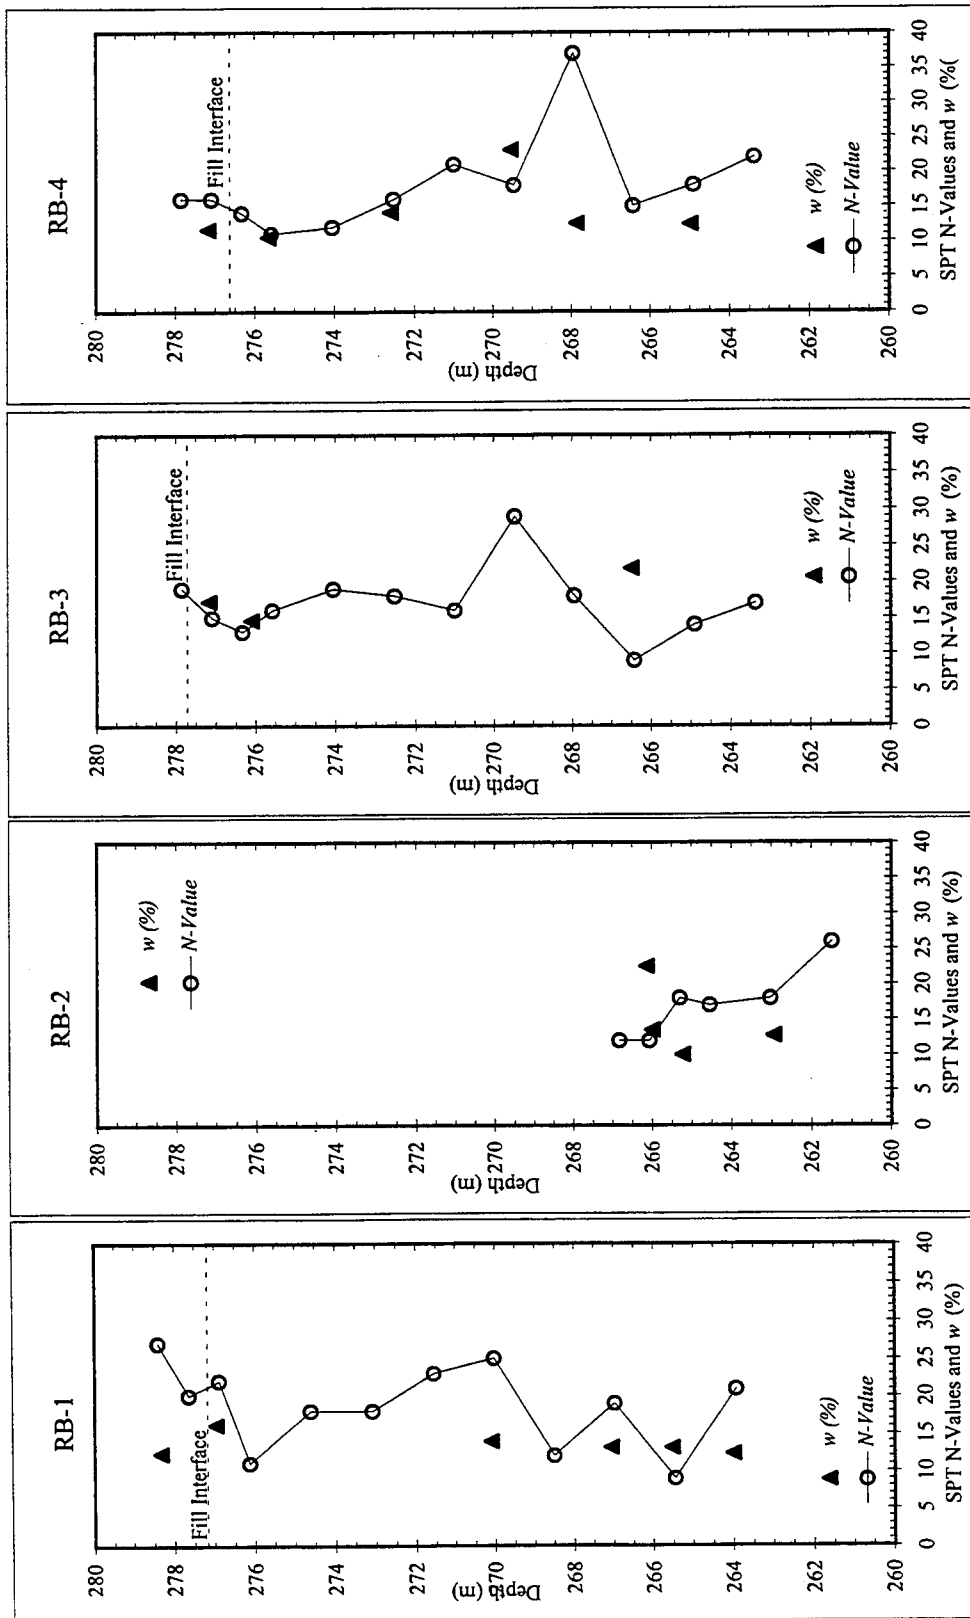
Figure 4.11. Standard penetration test data and water content profiles, I-69, Grant County, Fort Wayne District.

Four borings were advanced by INDOT subsequent to failure. SPT and moisture content profiles are presented in Figure 4.11. RB-1, RB-3 and RB-4 were advanced through the embankment. RB-2 was advanced at the toe of the embankment. The maximum estimated depth of the fill ($\approx 1.83\text{m}$) based on sideslope geometry is presented on the profiles; however, observations made in test pits indicate that the depth to original

ground was shallower. The borings indicate that the consistency of the soil comprising the embankment and foundation is stiff to very stiff. No weak zones indicative of a rupture zone were noted.

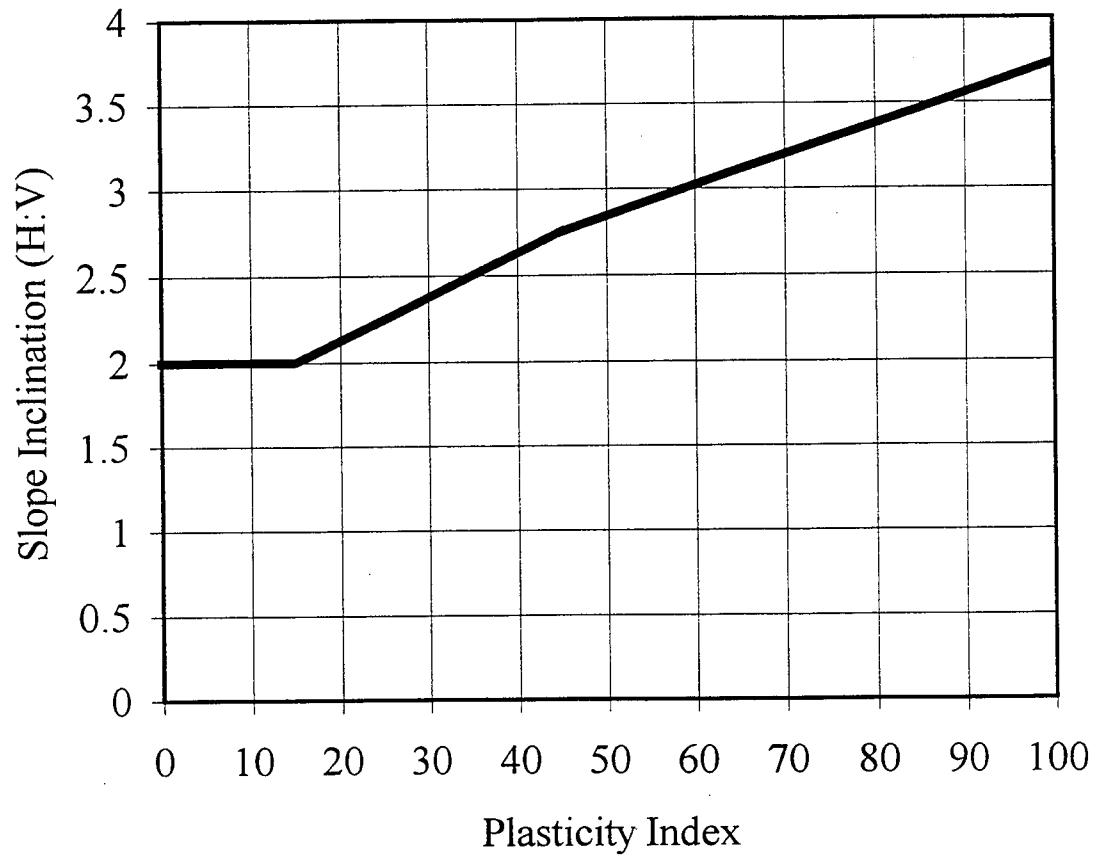
Figure 5.2 Recommended slope inclination as a function of plasticity

The data from Mitchell (1974) were used to develop a simple relationship between plasticity index and slope inclination that is recommended for soils otherwise compacted according to the INDOT *Standard Specifications*. The relationship is provided in both graphical (Figure 5.2) and tabular (Table 5.1) formats. These recommendations were developed assuming prompt development of vegetative cover and controlled transmission of surface water runoff. Moreover, the slope inclinations

recommended are not applicable if there is a potential for groundwater movements within the embankment. It is believed that steeper slopes than those recommended here may be adequate at some sites, however, this would require documentation from a detailed stability analysis using appropriate strength parameters for the specific embankment soils that will be used in construction.
